Belchatow 858 MW WTP

By Rami E. Kremesti M.Sc.

Block Diagram

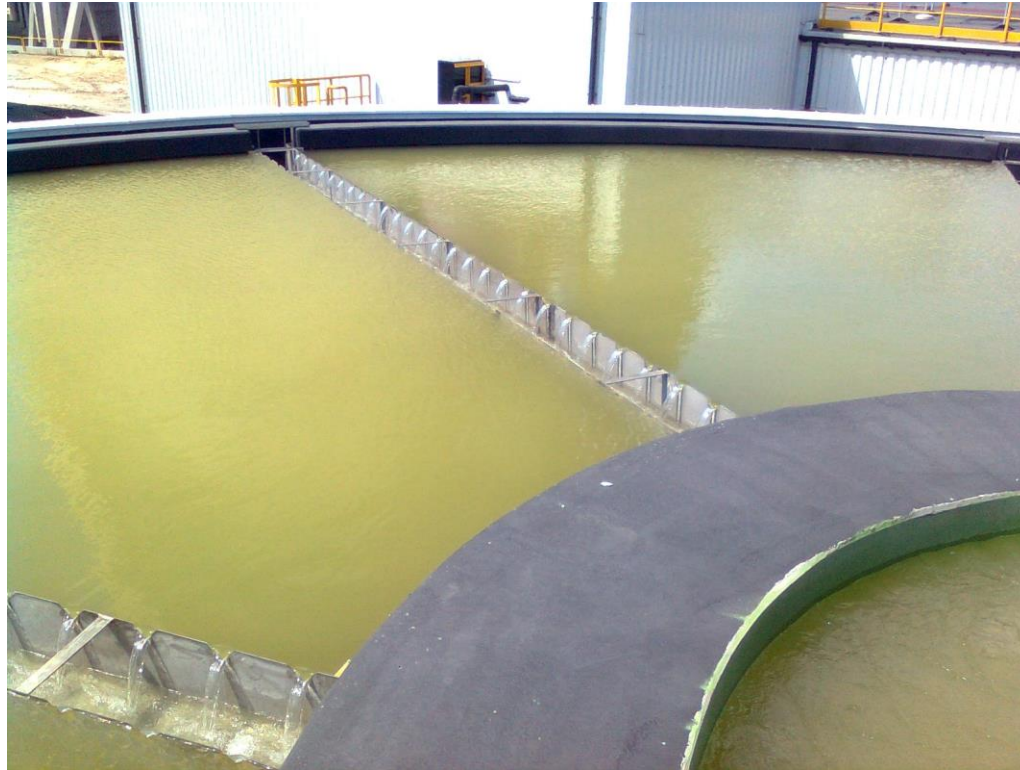
Clarifier Bad

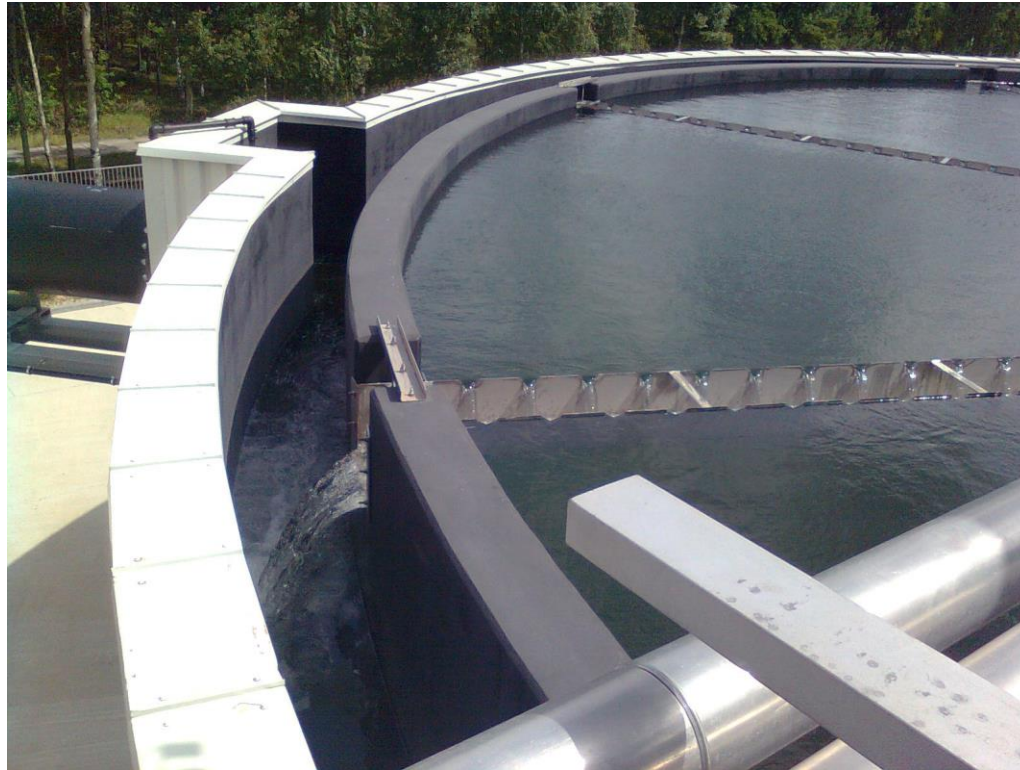
Clarifier Good
