Belchatow 858 MW WTP

By Rami E. Kremesti M.Sc.

Block Diagram

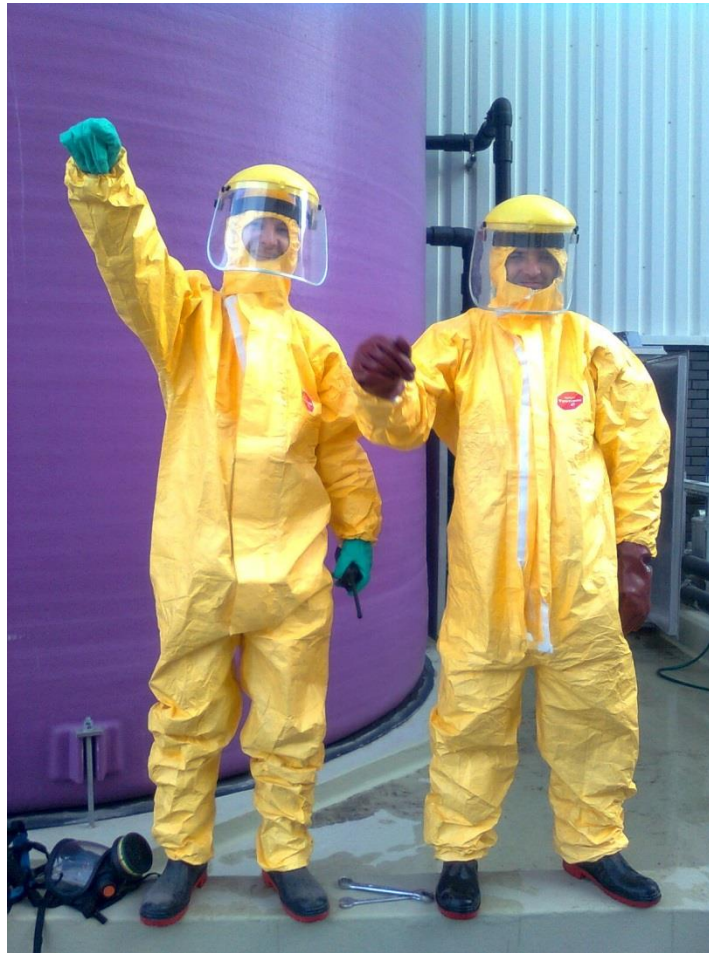
Chemical Unloading HCl

- 15. bad HCl acid leak from flange on one of the unloading cabinets lead to destruction of aluminum housing
- 16. Lime mixing impellers were eroded after one year: make sure material is suitable.
- 17. Some pumps were vibrating and we needed to reinforce the supports
- 18. Issues with CO₂ contamination of demin water tank. Prefer filling line to come to bottom of tank to avoid splashing. Issues with overflow line air lock

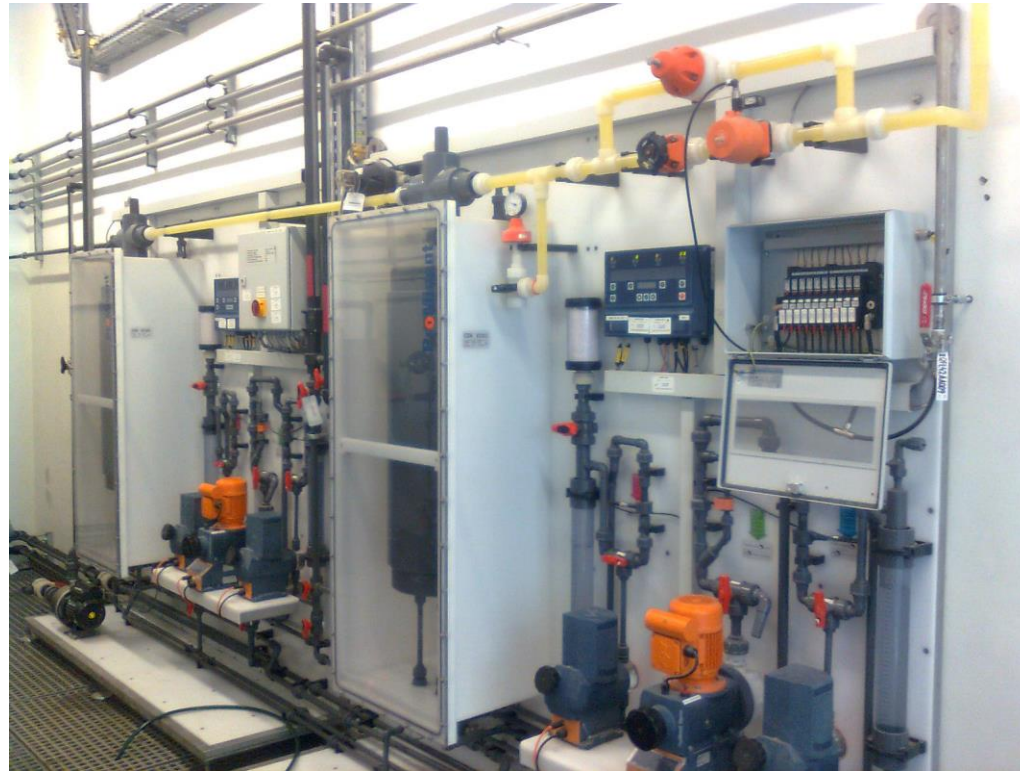
ClO₂ Dosing Station

- Leaking pipe wall penetration for neutralization basins (Civil)
- *Prominent* recommended changing gaskets/membranes for ClO₂ plant every 6 months (too early)
- Client was acting difficult (political)
